# **LaGuardia Airport Case**

## **FACTUAL BACKGROUND.**

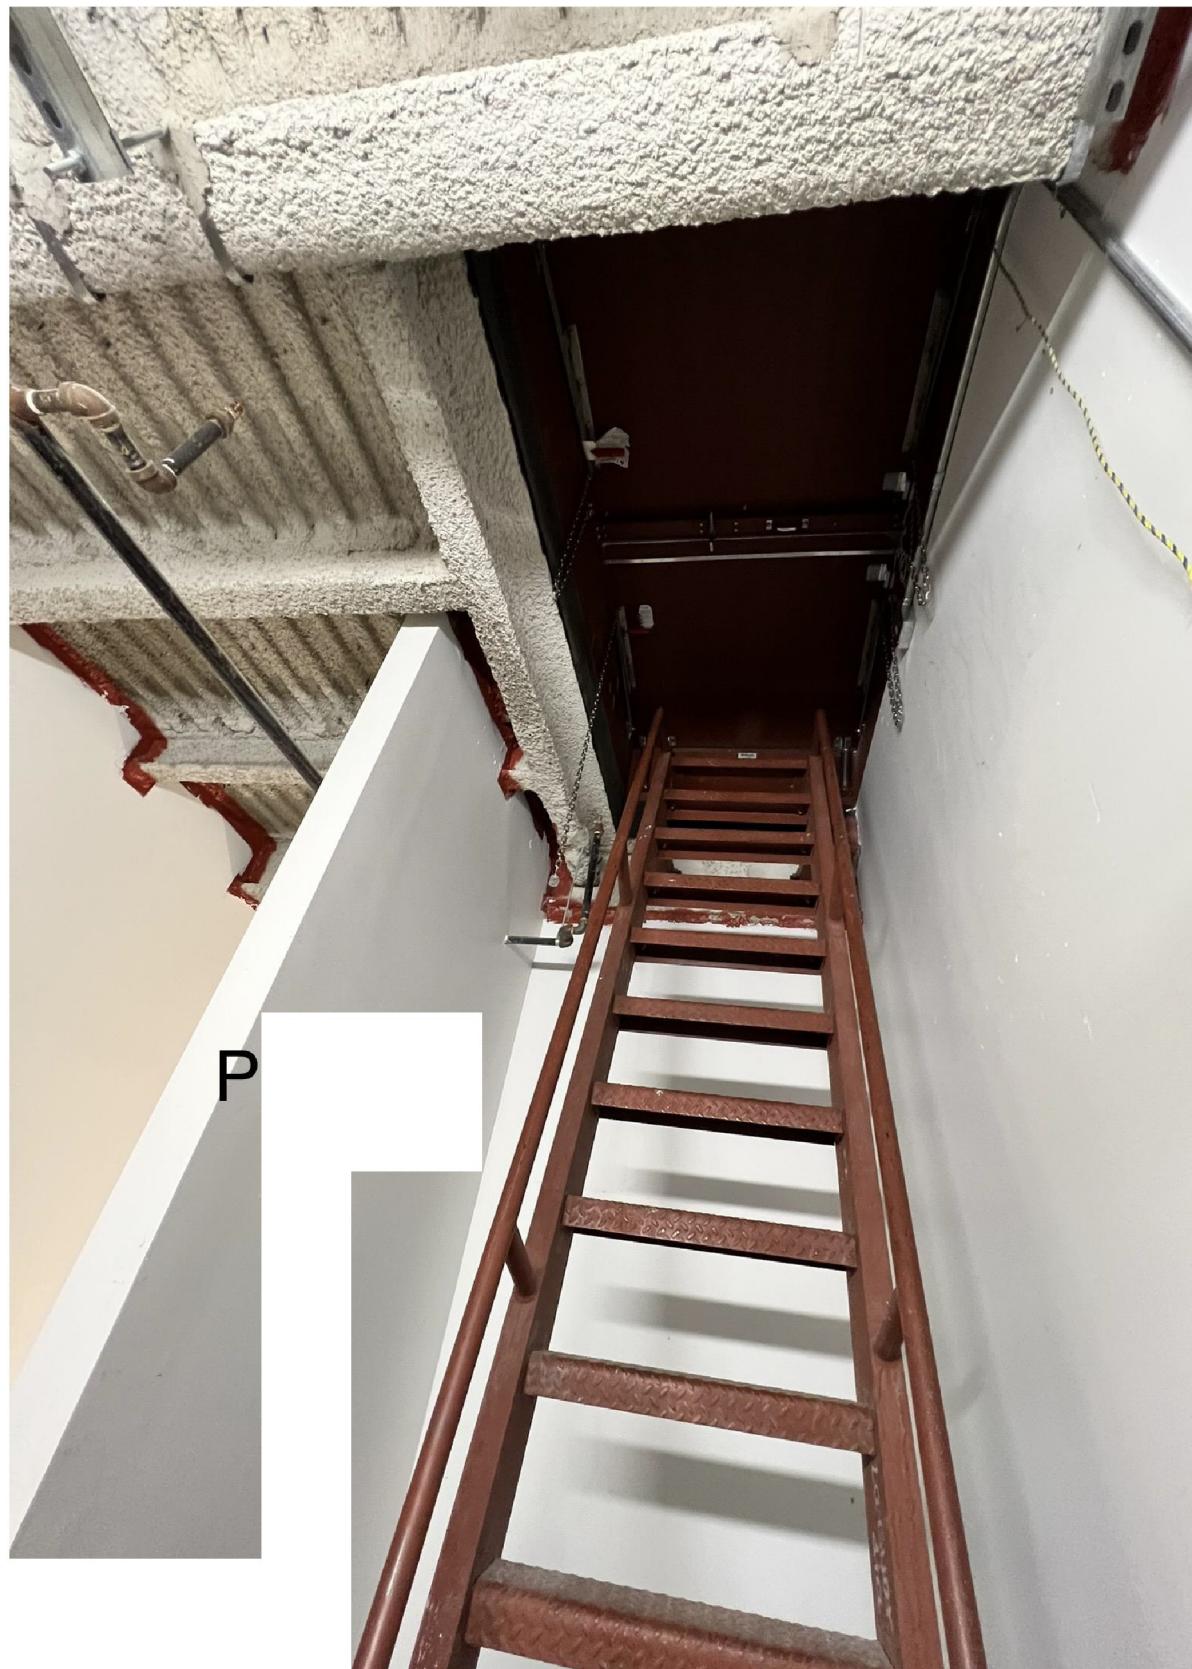
(2) The roof hatch in question, manufactured by Bilco, serial #60296271 is a wide two leaf roof hatch. The defendants installed a fixed ladder leading up to the roof hatch at approximately a 70.6 degree angle (see photo #1)

(1) In my professional opinion roof hatches from manufactures like Bilco can provide safe and convenient access to roof areas by means of an interior ladder, ship stair or service stair leading to a door that opens to the side so that a worker does not have an obstruction in the way. However, this roof hatch configuration, where the hatch doors open directly in front of and block the path of egress, should only be utilized to provide a convenient way to install or remove large pieces of equipment from a building. It should never be used by workers to get on or off the roof. The fact that the defendant allowed this particular roof hatch as a means of egress for workers is a direct violation of Labor Law 240 (1) and a failure to provide reasonable and adequate protection to the lives, health and safety of persons employed. Further, in my professional opinion, the Defendants failure to provide proper and safe means of egress to and from the roof was the direct cause of the Plaintiff's fall from the top of the ladder.

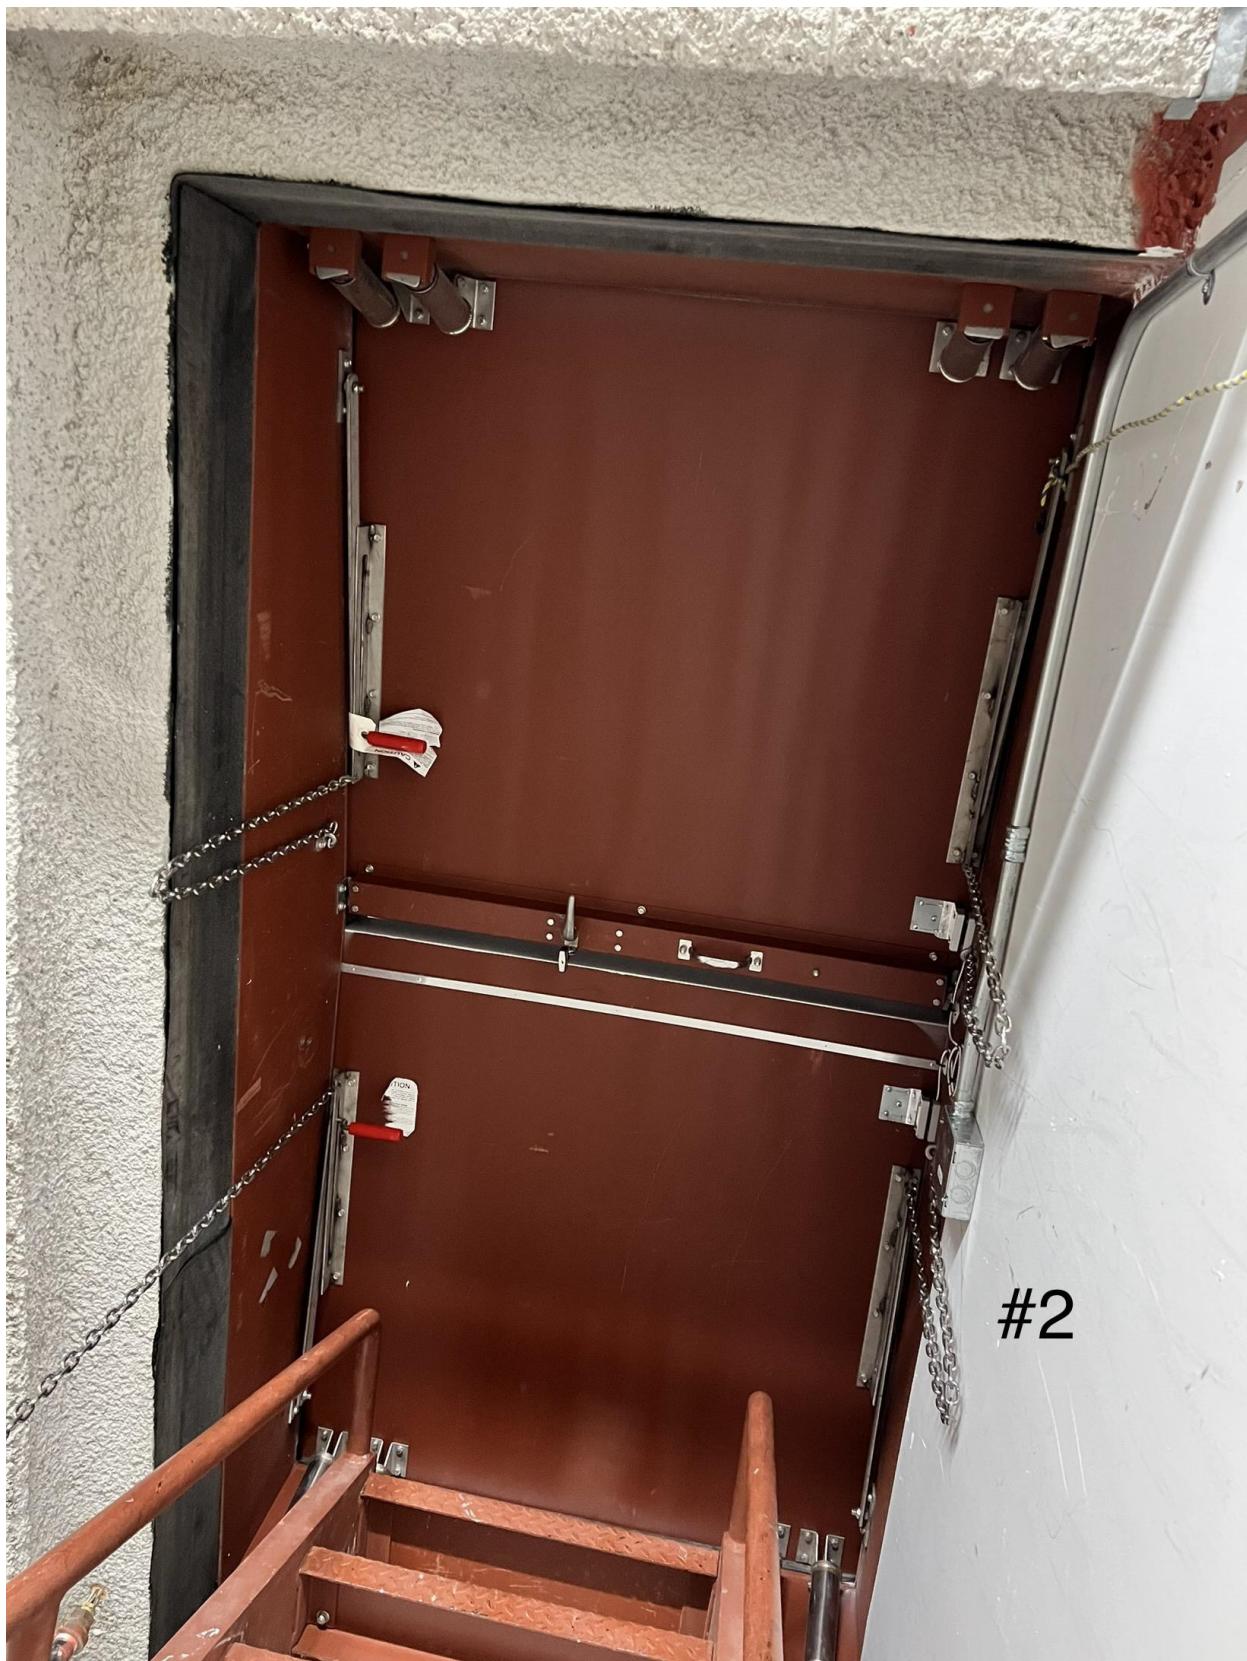
As you climb up the ladder you need to hold on to the stair rail with one hand and

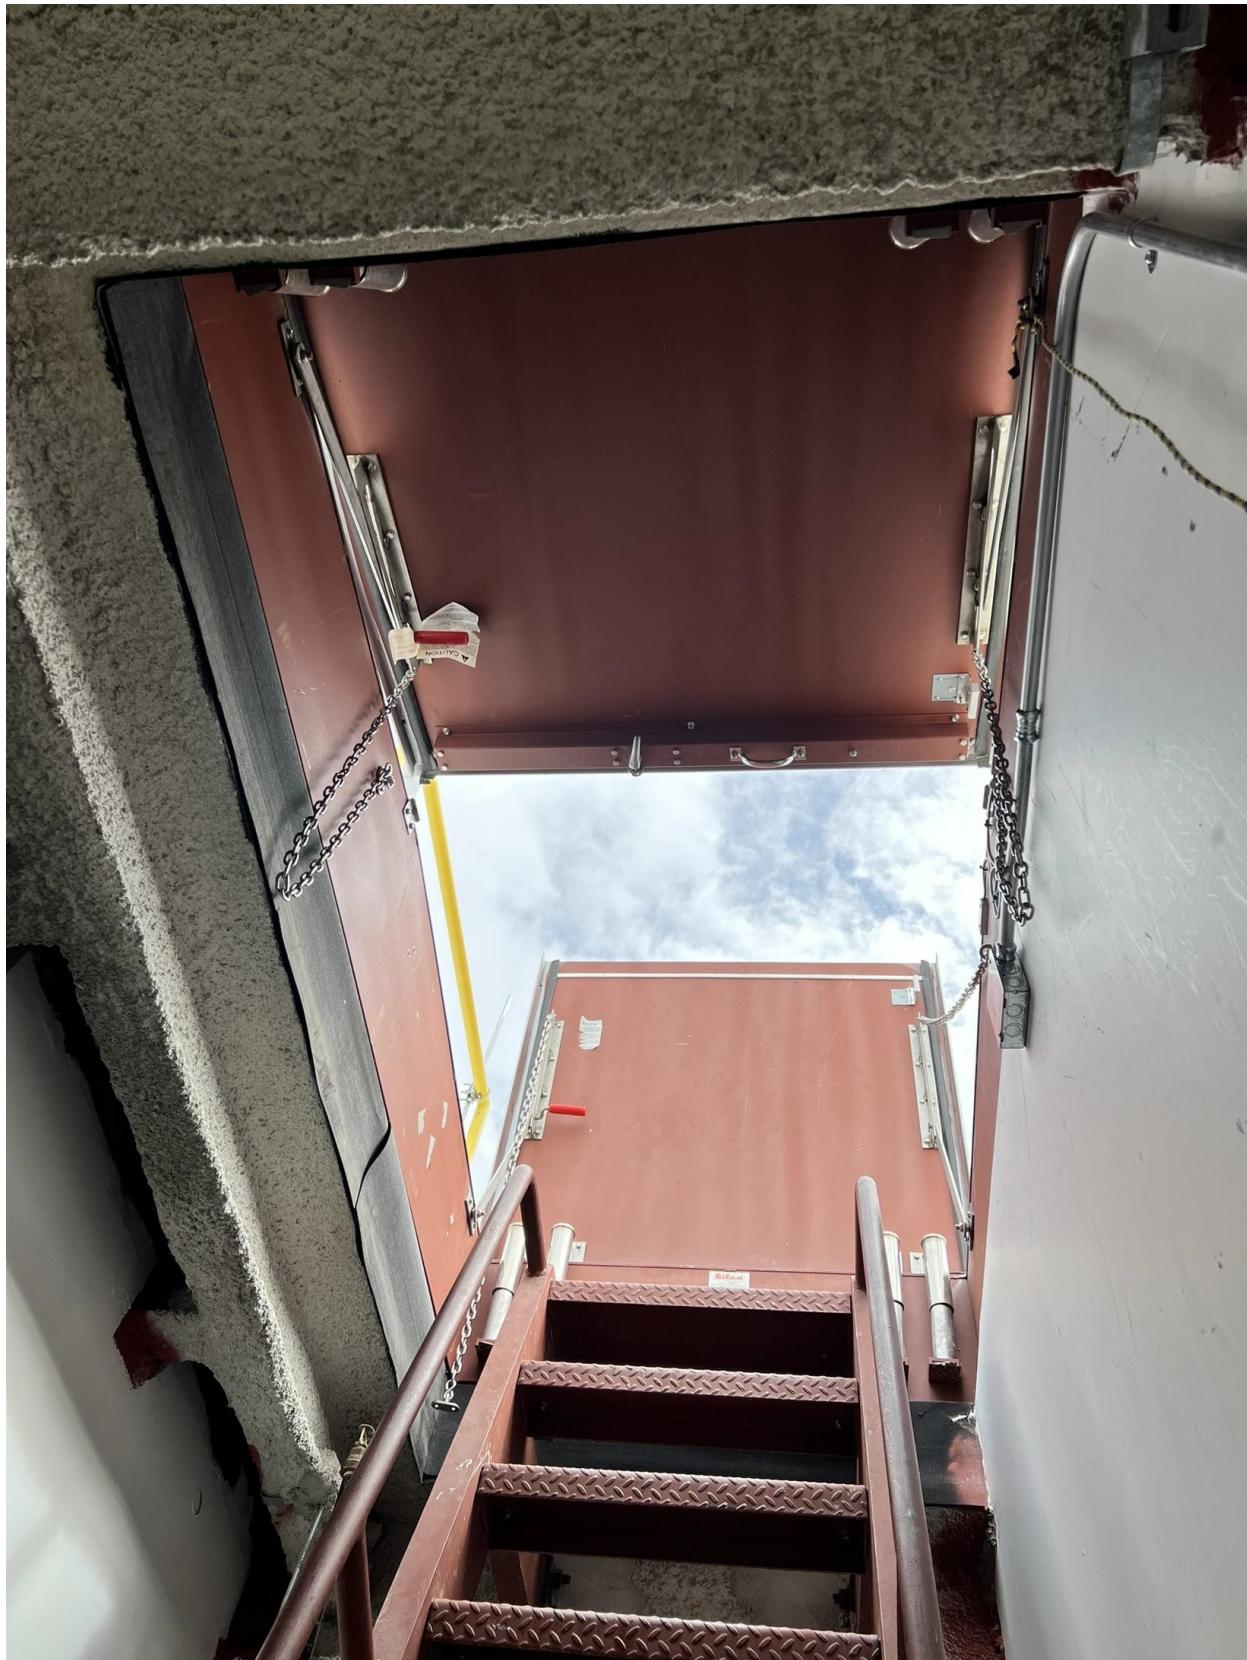
After the left door is open, you can then push open the door to the right. The right door at the top of the ladder does not open to the side to allow for reasonable egress. But rather, it opens directly in front of you in a 90 degree angle acting as a wall blocking any means of egress (Photo #3).

The proper roof hatch should have been "constructed, placed and operated as to give proper Protection and allowed the Plaintiff a safe method of gaining access to and from the roof. The hatch door should have opened and operated to the side to allow for an unobstructed entry to the roof. The hatch door should have had a mechanism to lock the door while it was open. The Defendants should have installed extension poles, as sold by Bilco, that extend through the hatch door to provide a point to grab onto for support while ascending or descending.

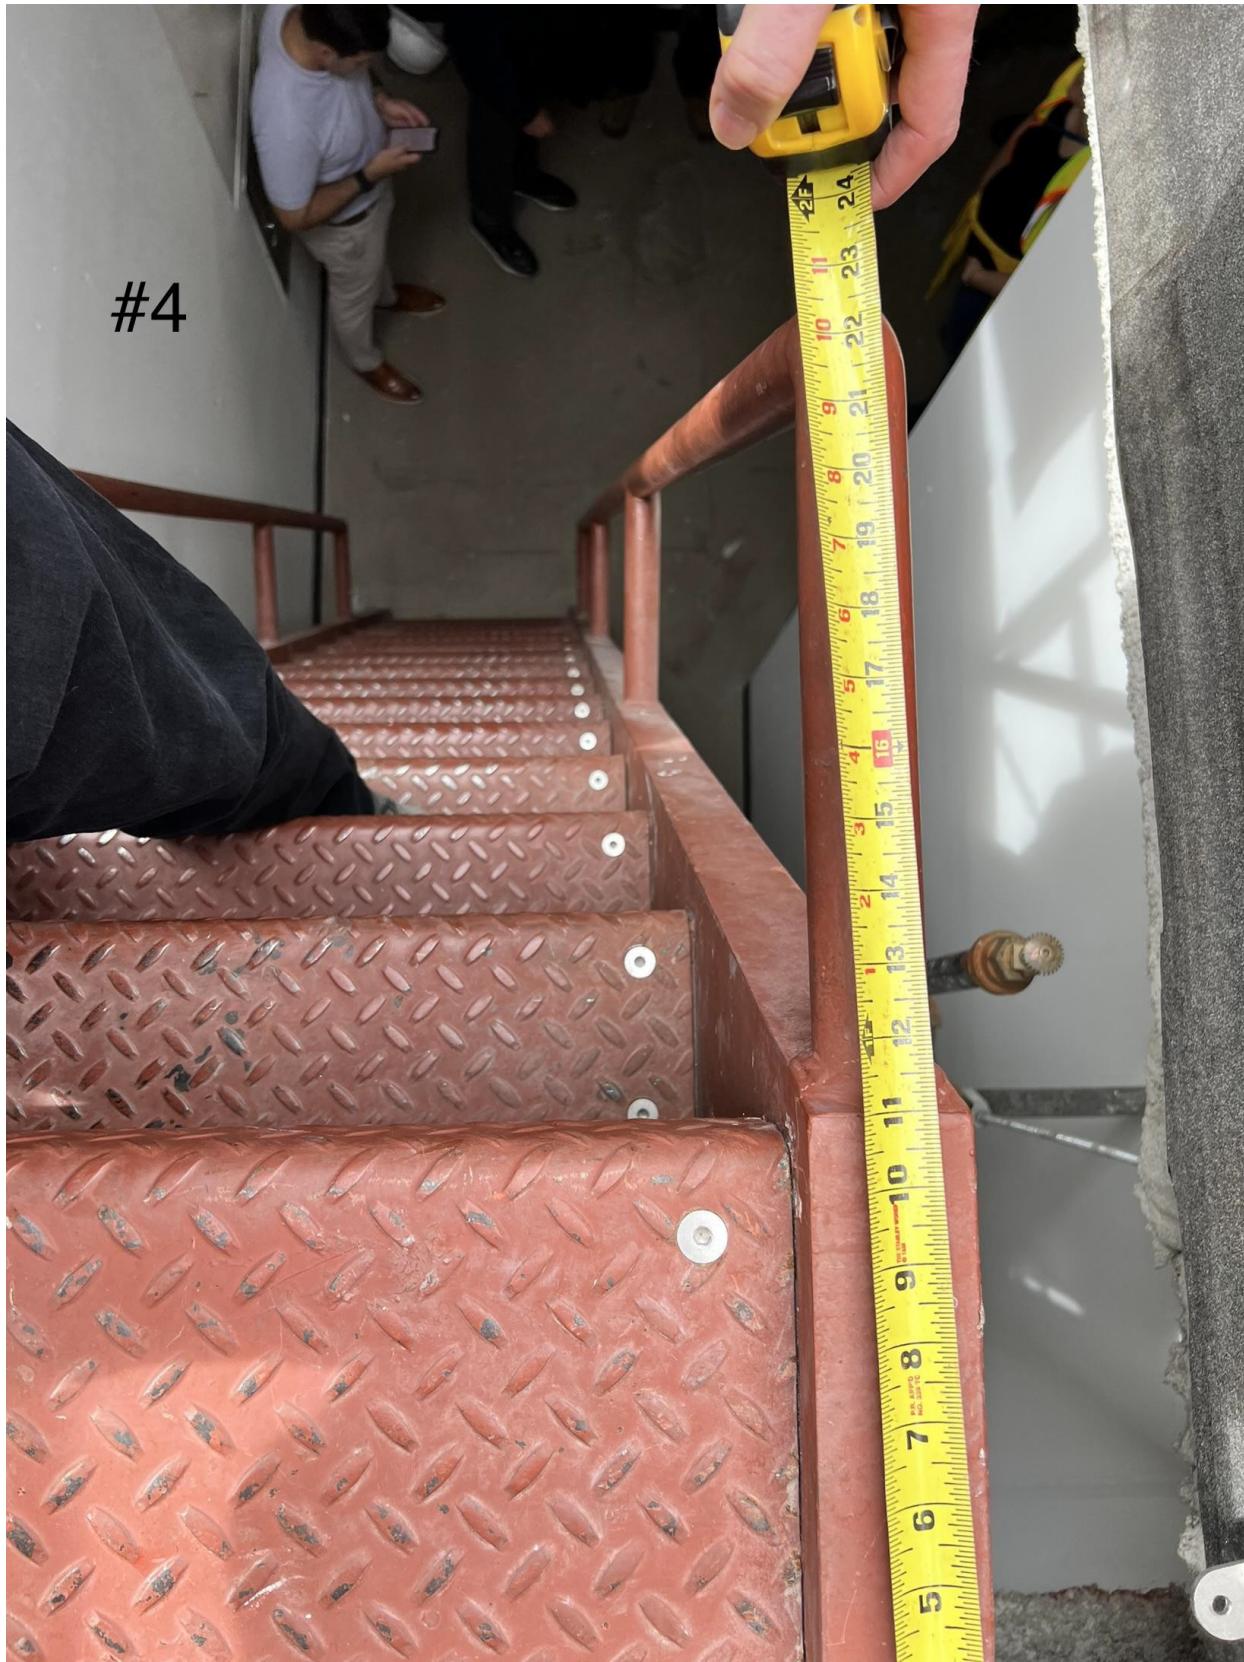
and the door blocking your path straight ahead, you need to somehow turn to your left

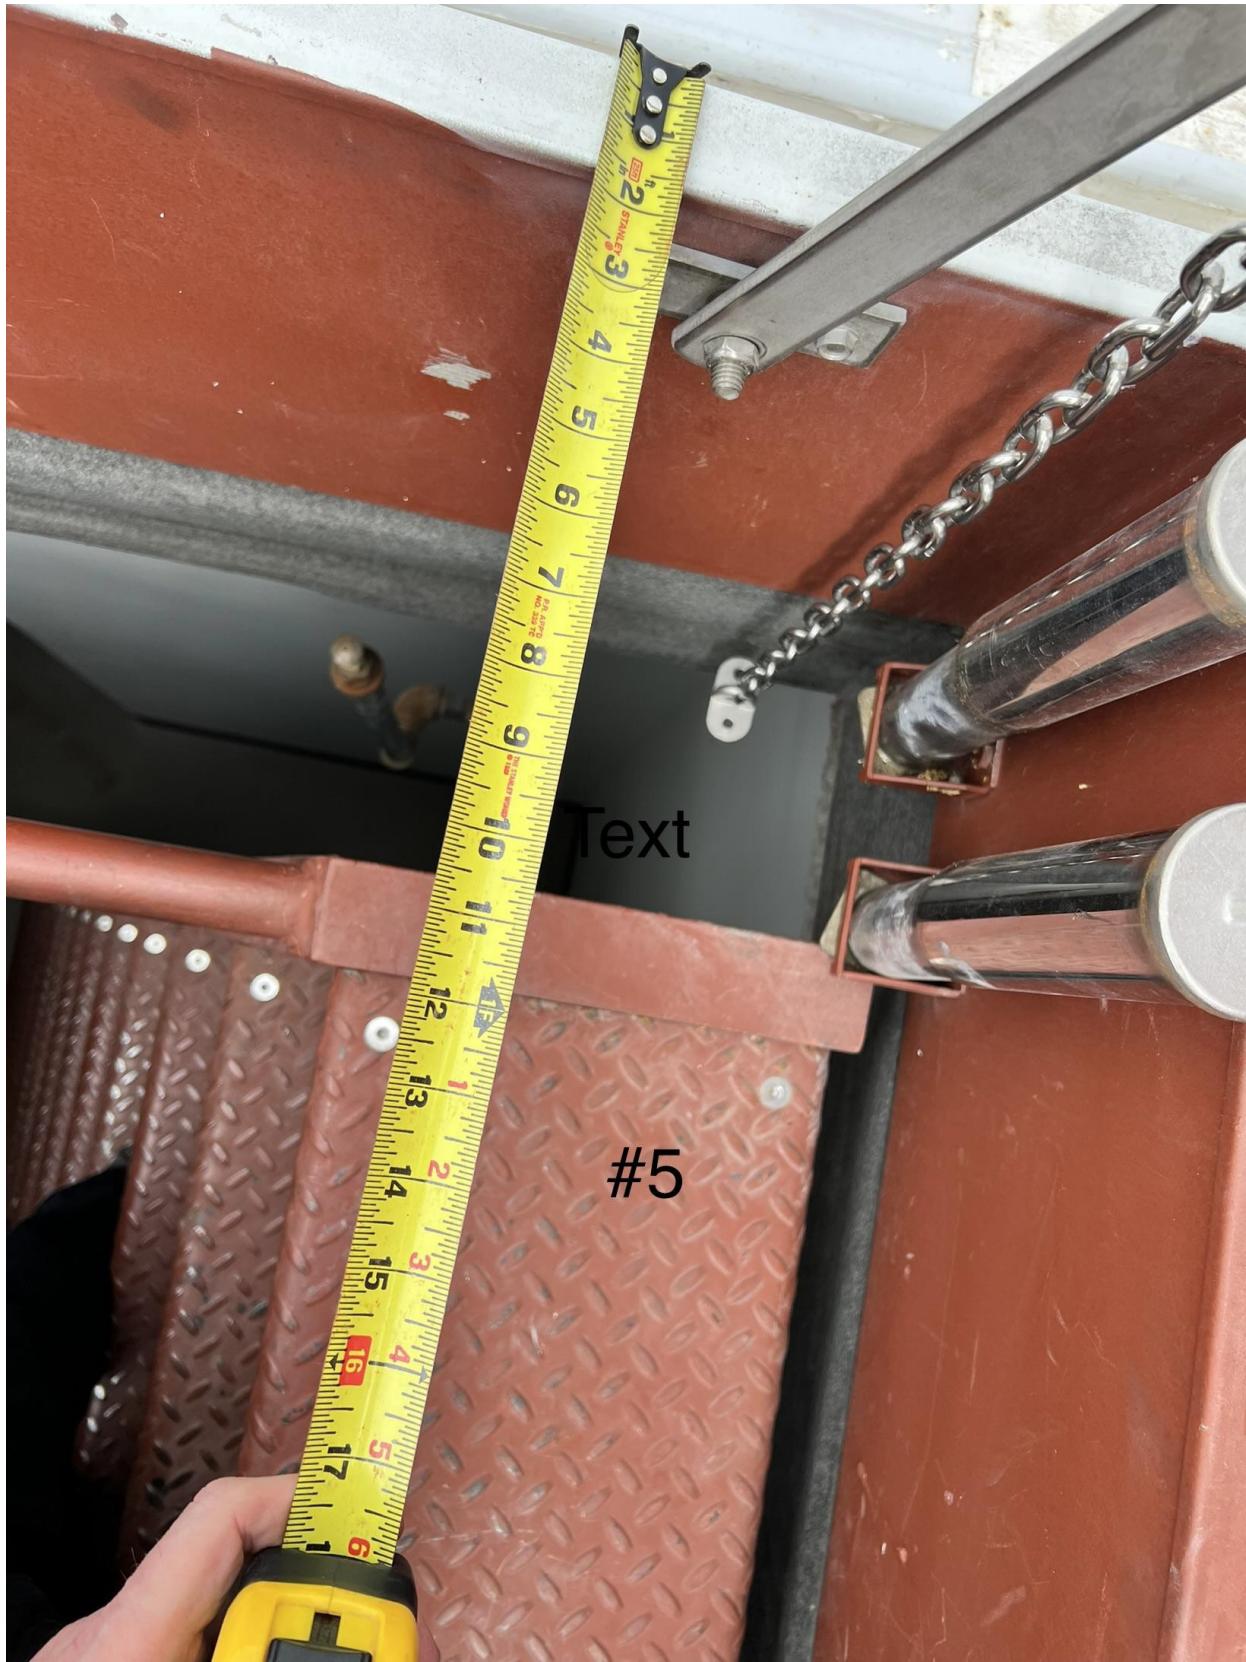
#5

and step over an 11" distance from the edge of the top rung to the top of the curb (Photo #5).

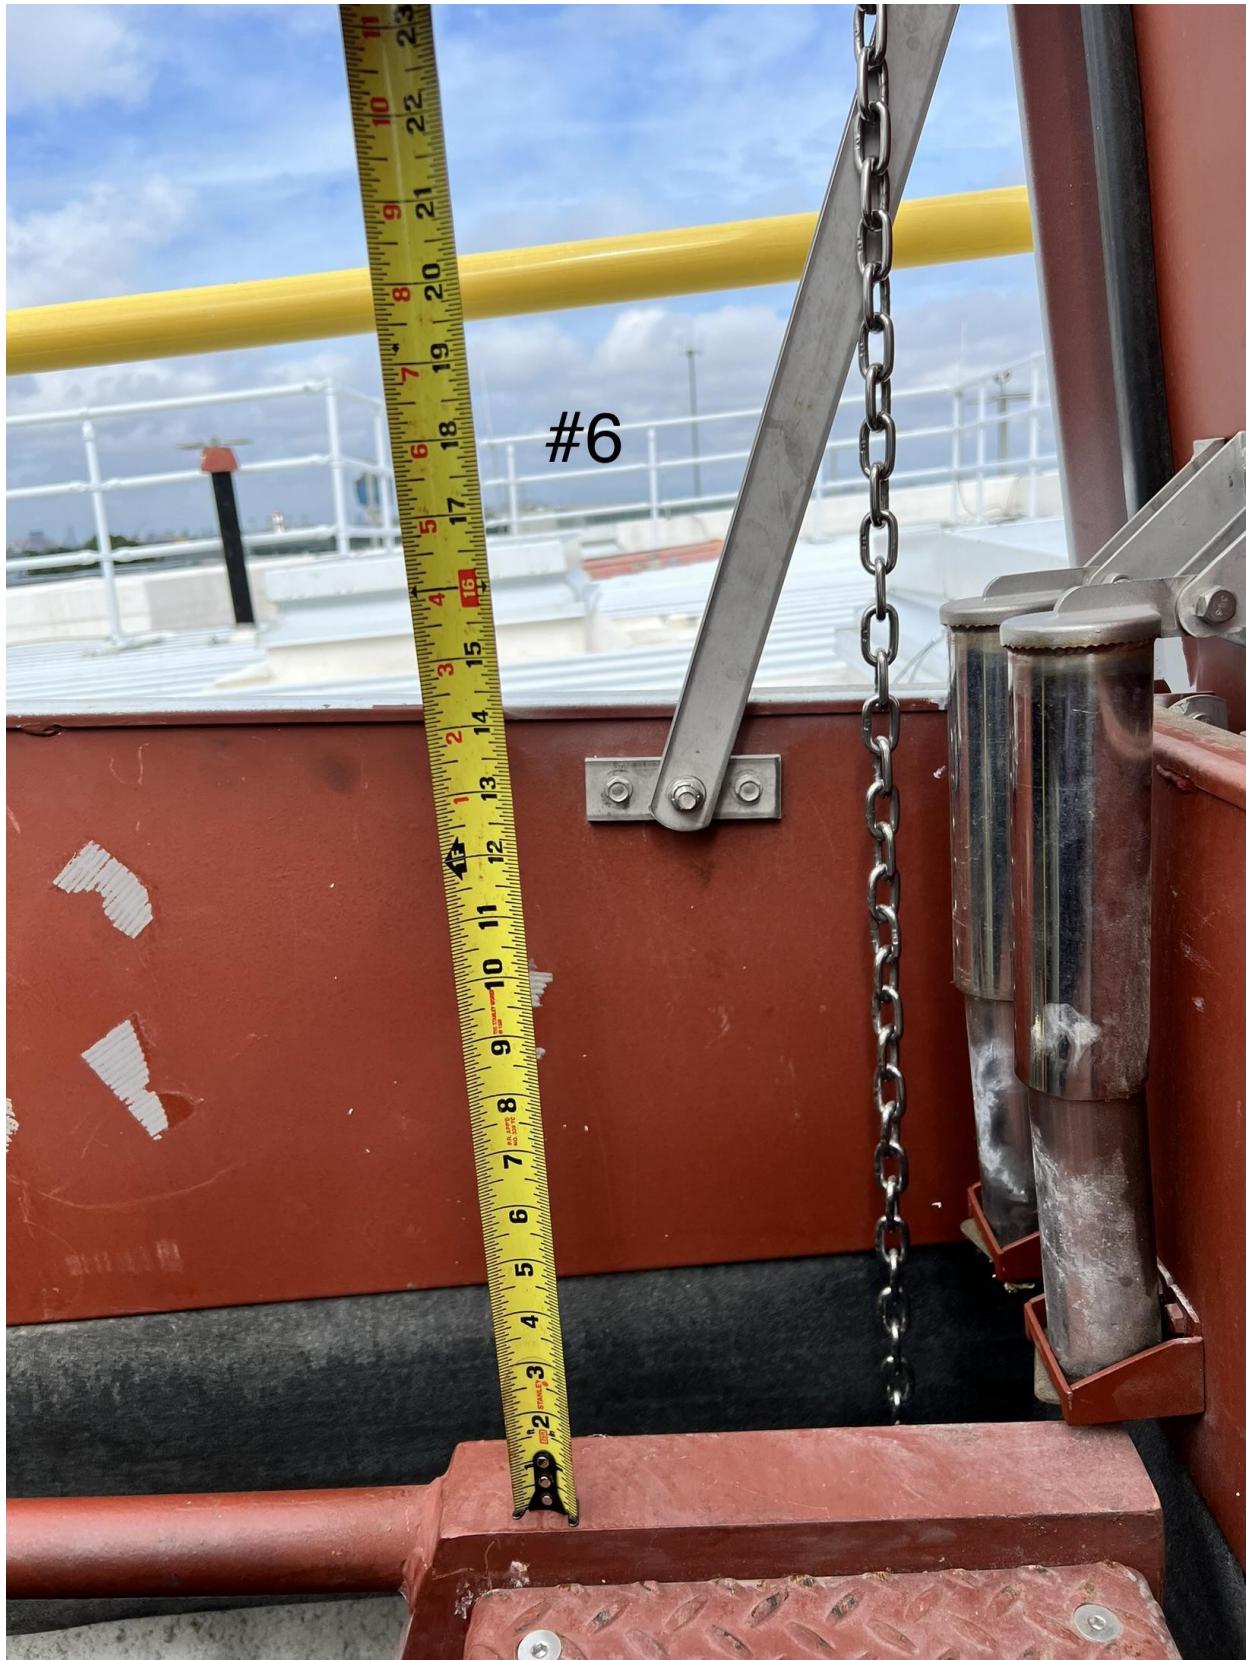
There is no rail to hold on while performing this dangerous twisting move and so ones

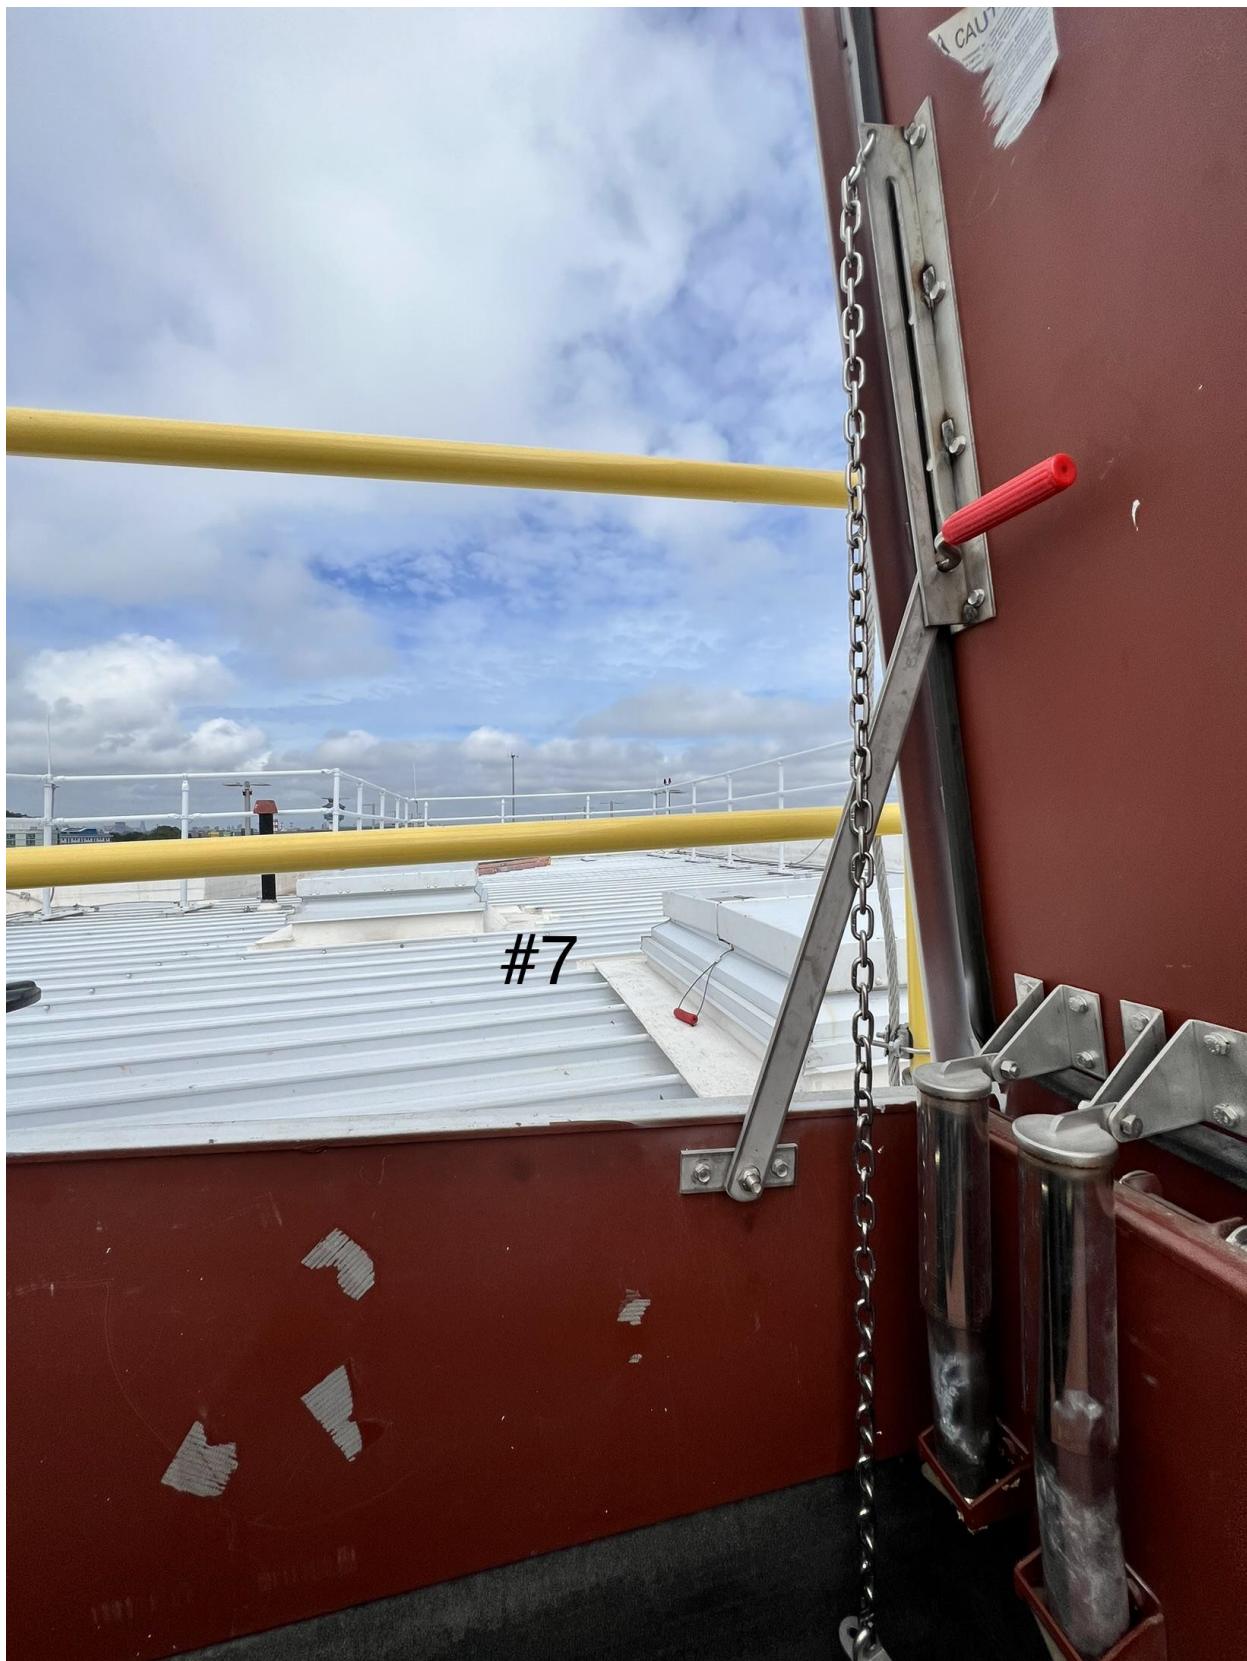
that will release the door and the door will close with very little pressure applied.
